LEUNG KAI FOOK MEDICAL COMPANY (PTE) LTD

Seepage Rectification Works

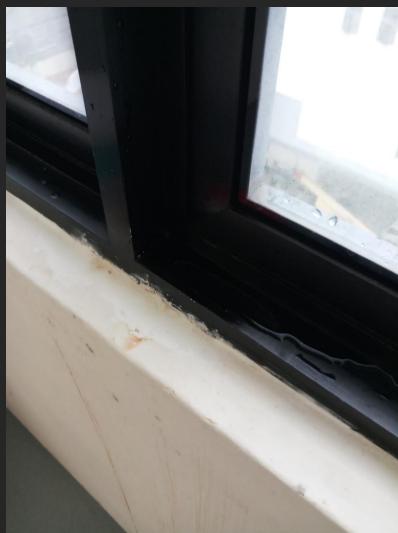
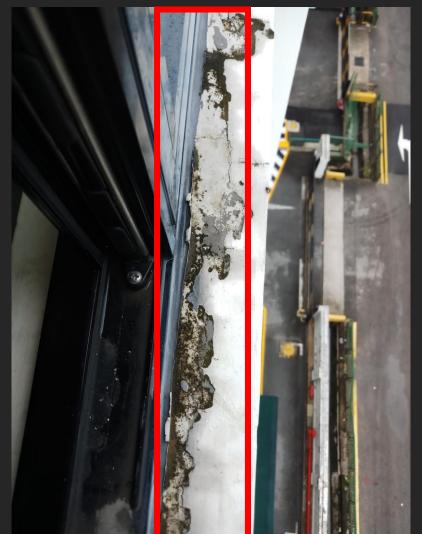
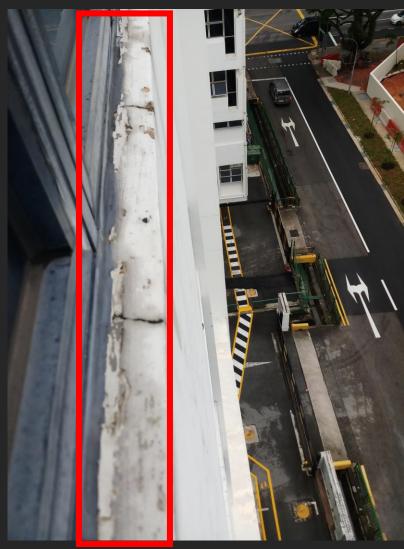
Water seepage through window frame and worn-off sealant between concrete and window frame
